### CHAIN DRIVE: METALLIC NOISE

**Manufacturers:** OPEL/VAUXHALL

**Models:** ASTRA J, INSIGNIA A / B, MERIVA B, MOKKA, ZAFIRA TOURER C

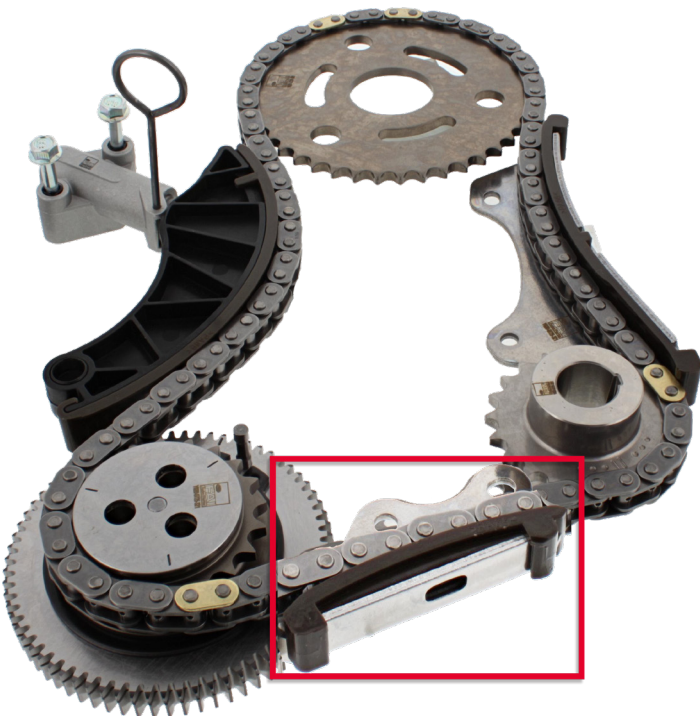
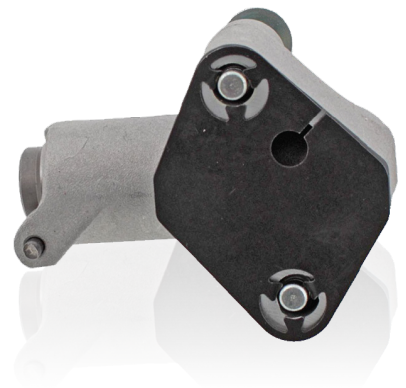
**Symptom:** Excessive chain noise at start up

**Cause :** Damaged timing chain lower rail

The improved tensioner design, including the gasket, prevents vibration of the chain due to incorrect pressure and avoids damage due to excessive stress on the guide.

Low oil pressure in the engine can result in excessive noise from the timing chain and also lead to damage of the lower chain guide.

The tensioner design has been modified to include a gasket that prevents oil returning to the sump when the engine is not in use. This ensures that there is always sufficient oil in the pre-filled chamber.

When replacing the timing chain system, check the sump, oil pump and oil filter for plastic contamination. Clean the system and replace parts if necessary.

If the oil warning light illuminates, check the condition of the oil pump and filter. Replace if necessary.
